The Falcon Group

ENGINEERING • ARCHITECTURE • ENERGY CONSULTANTS • FORENSICS • DRONE SERVICES

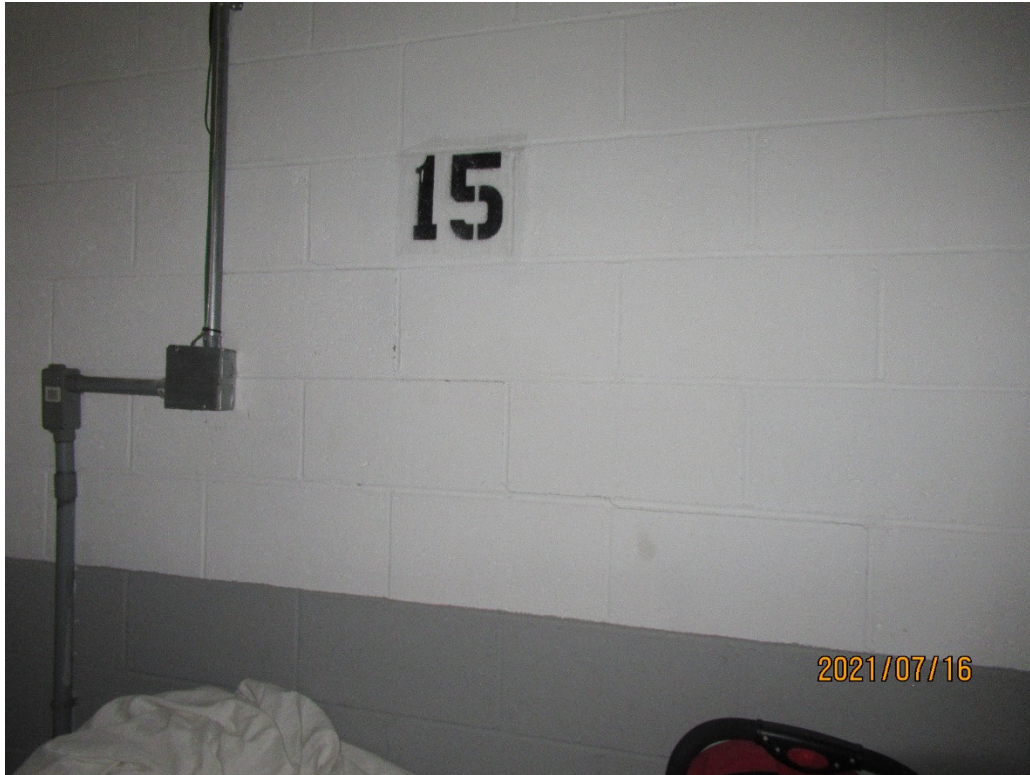
Figure 5. Minor Step Cracking at Masonry Block Exterior Wall at Northwest Building Corner

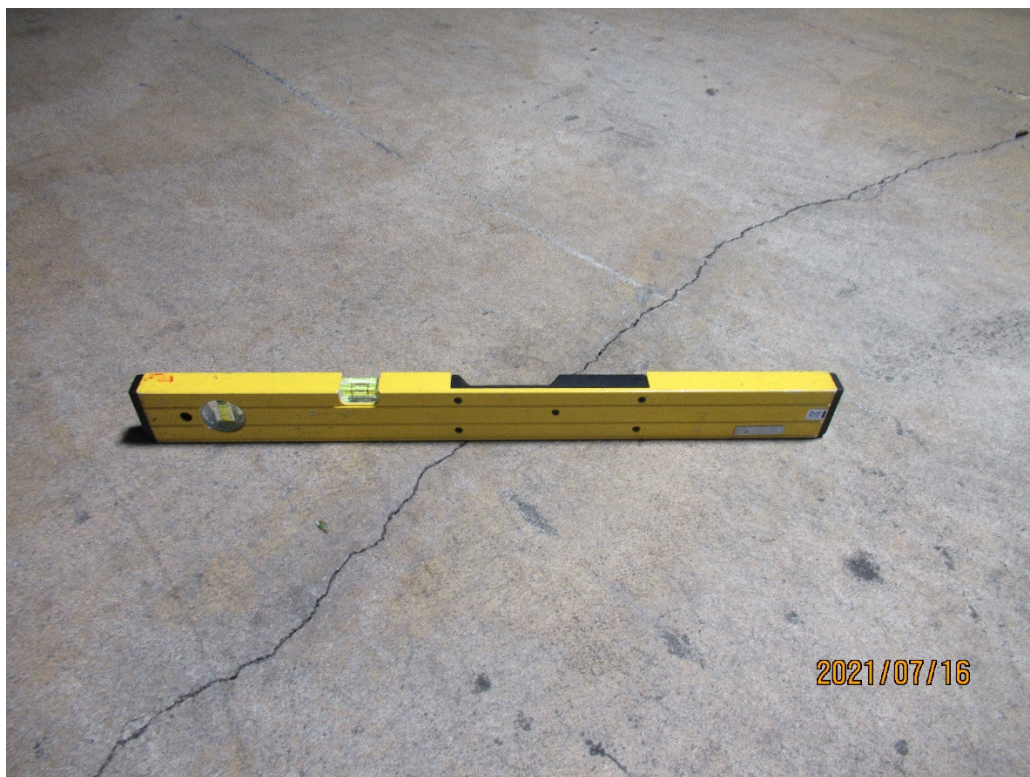
Figure 6. Crack at Ground Supported Concrete Slab at Parking Garage (Note No Vertical Displacement)

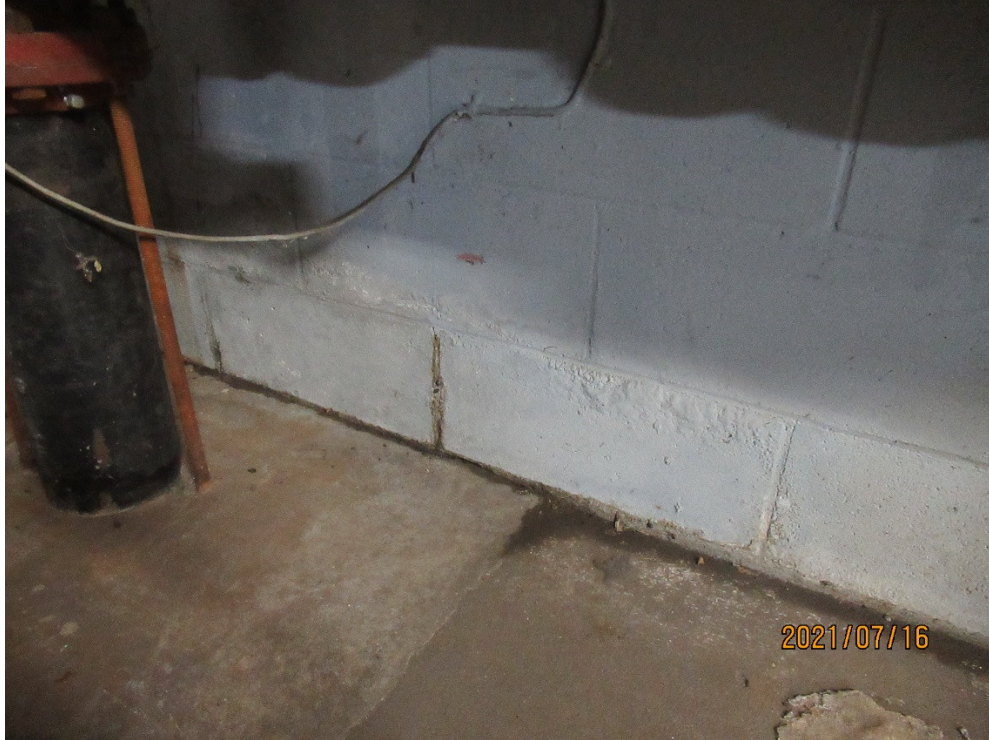
Figure 7. Minor Seepage at Base of West Facing Exterior Wall at Parking Garage

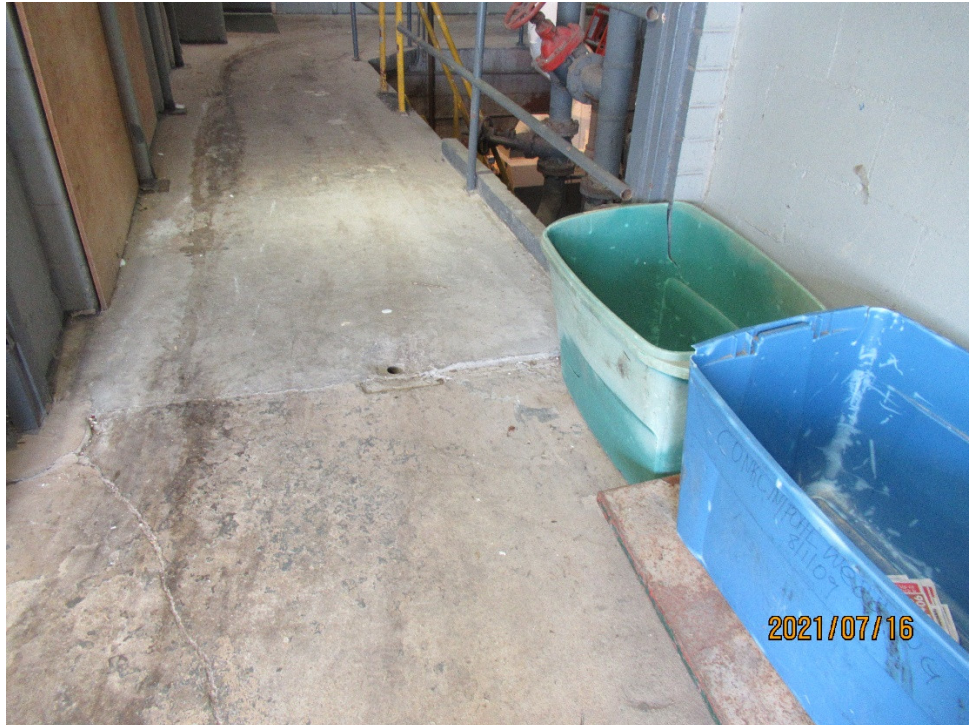
Figure 8. Cracking and Minor Vertical Displacement of Ground Supported Slab at One Story Refuse Room at Northeast Corner of Residential Tower
